# New Hampshire Volunteer Lake Assessment Program

## 2003 Biennial Report for Stocker Pond Grantham

NHDES  
Water Division  
Watershed Management Bureau  
29 Hazen Drive  
Concord, NH 03301

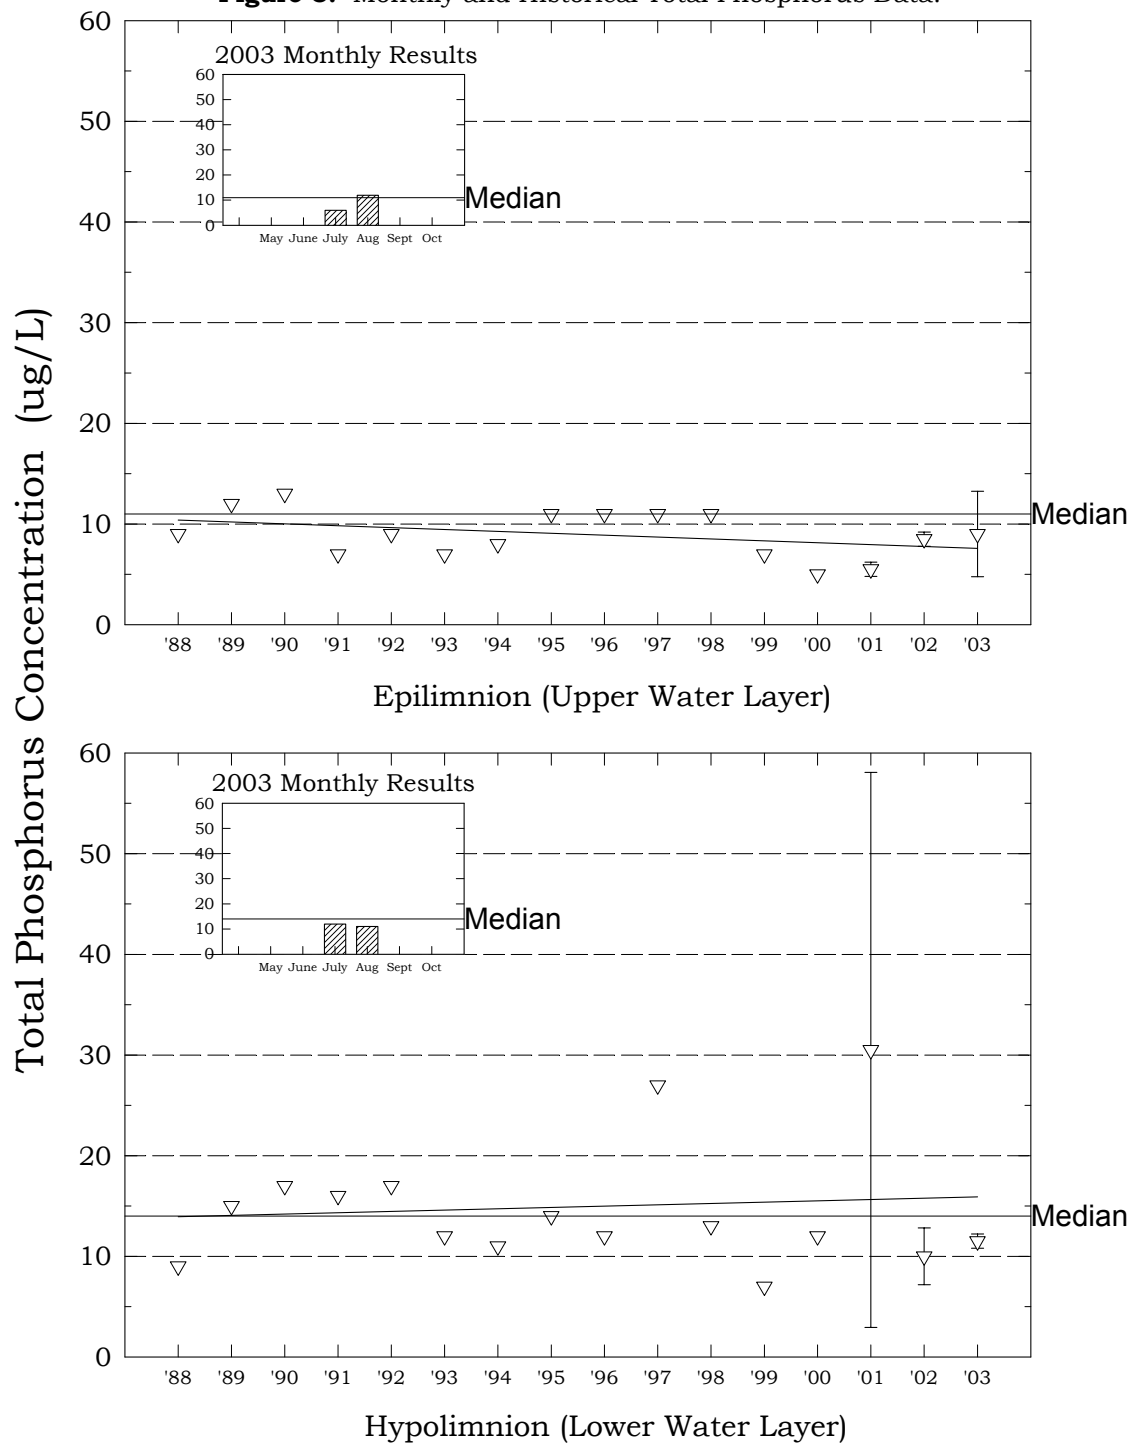
**Figure 3.** Monthly and Historical Total Phosphorus Data.

The current year data for the epilimnion (the top inset graph) show that the phosphorus concentration **increased** from July to August. The phosphorus concentration in July was **less than** the state median, while the phosphorus concentration in August was **slightly greater than** the state median

The historical data show that the 2003 mean epilimnetic phosphorus concentration is **slightly less than** the state median.

The current year data for the hypolimnion (the bottom inset graph) show that the phosphorus concentration **decreased very slightly** from July to August. The phosphorus concentration on both sampling events was **less than** the state median.

Overall, the statistical analysis of the historical data show that the phosphorus concentration in the epilimnion (upper layer) and the hypolimnion (lower layer) has **not significantly changed** since monitoring began in **1988**. Specifically, the phosphorus concentration in the epilimnion has remained **relatively stable** while the phosphorus concentration in the hypolimnion has **fluctuated**, but has *not continually increased or continually decreased*, since

monitoring began. (Note: Please refer to Appendix E for the statistical analysis explanation and data print out.)

One of the most important approaches to reducing phosphorus loading to a waterbody is to continually educate watershed residents about its sources and how excessive amounts can adversely impact the ecology and value of lakes and ponds. Phosphorus sources within a lake or pond's watershed typically include septic systems, animal waste, lawn fertilizer, road and construction erosion, and natural wetlands.
